AEROSTAR CONTINUED
AIRWORTHINESS INSTRUCTIONS

AEROSTAR (RAVEN) HOT AIR BALLOONS

ACAI
PART I

Type Certificate No. A15CE

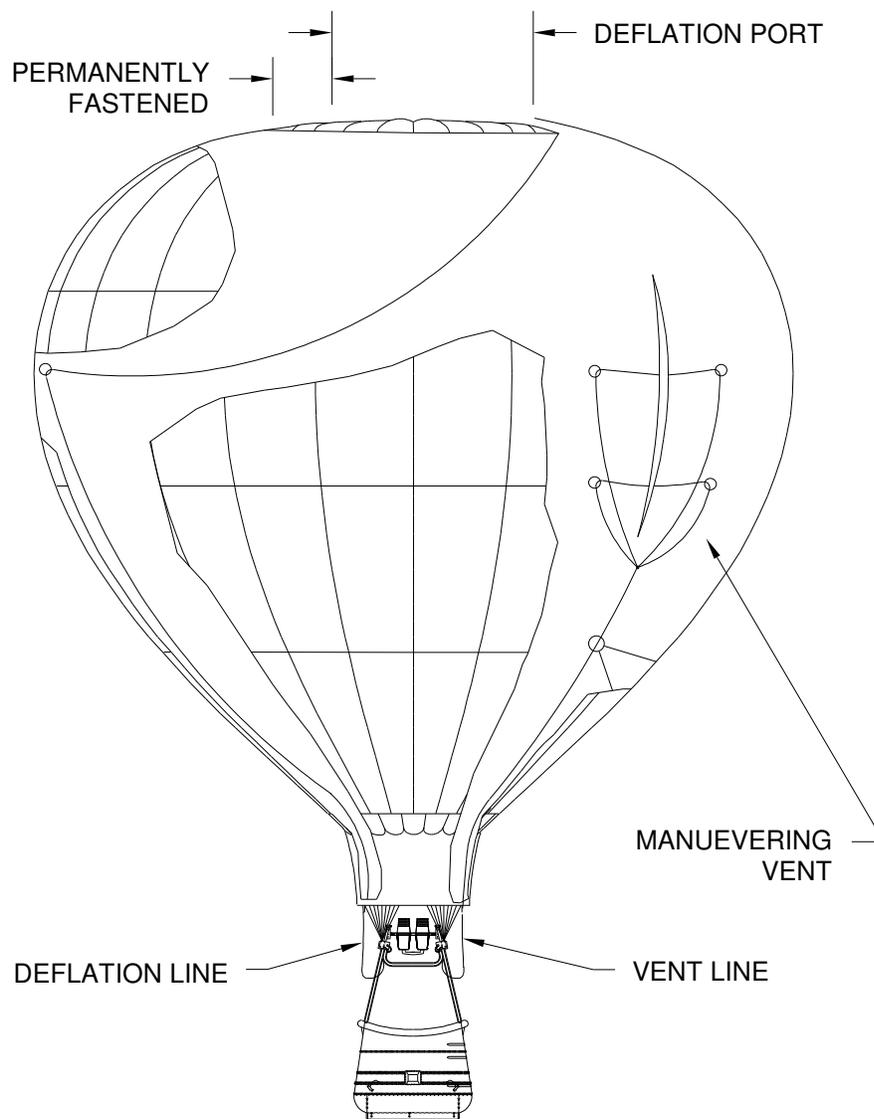
Figure 1.1.1 Rip Top Envelope Design

The **RIP TOP** design, figure 1.1.1, has a circular panel sewn for 1/3 the distance around the deflation port at the top of the balloon.

The other 2/3 is sealed by the use of hook and pile fastener tape. An actuation line is attached to the edge of the hook and pile fastener sealed "rip" top, and extends to the basket, permitting the panel to be pulled open as a means of deflating the envelope.

Balloons with a rip top deflation system also have a maneuvering vent located on the side of the envelope. The maneuvering vent is a vertical opening that may be actuated by pulling on a line that is connected to the sides of the vent by means of actuation lines and D-rings. When the line is released, the vent automatically closes.

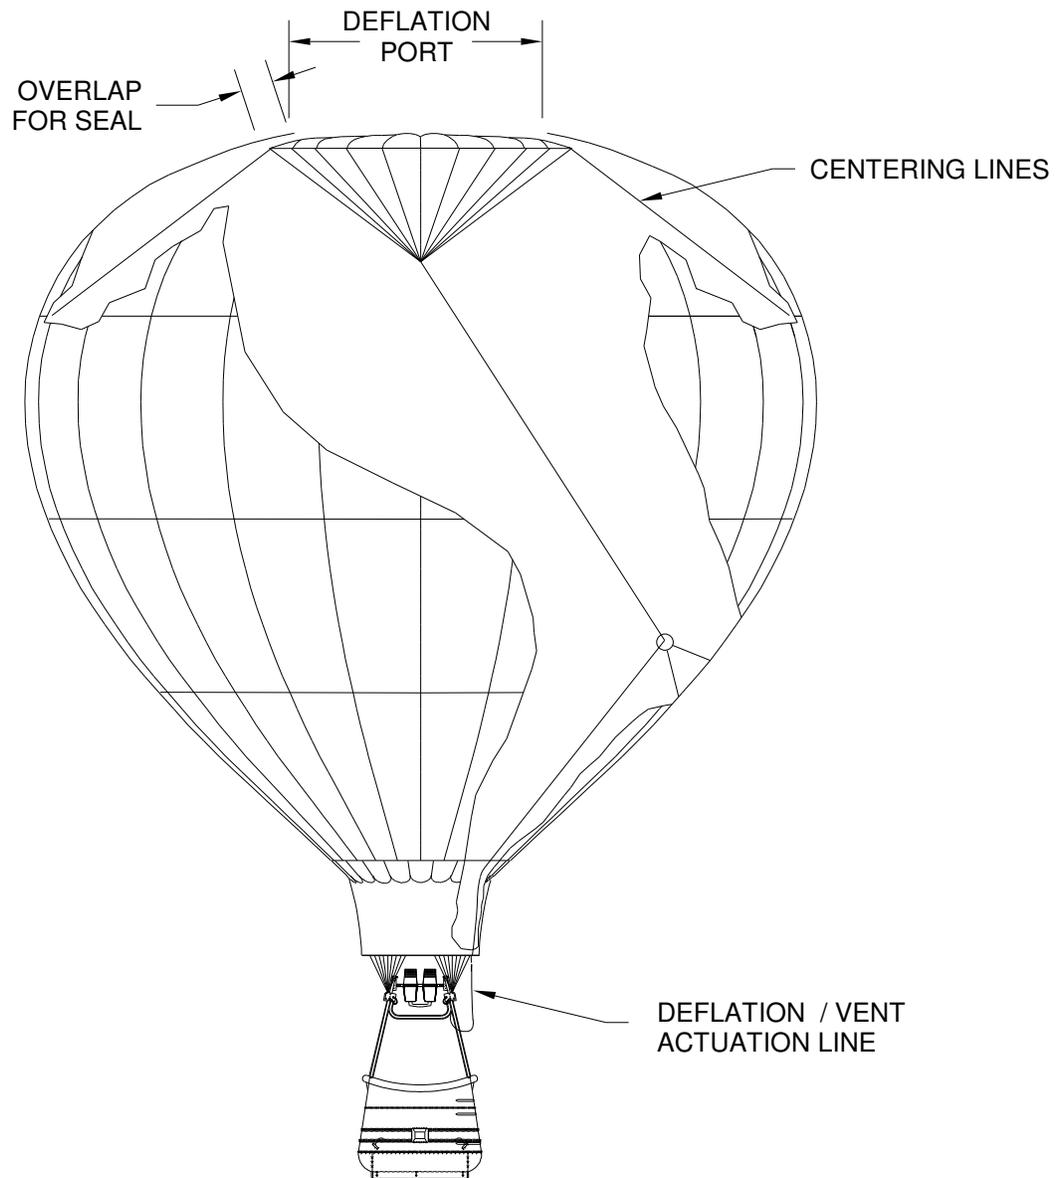
Figure 1.1.2 Parachute Top Envelope Design

The **PARACHUTE TOP** design, figure 1.1.2, employs a parachute style panel covering the deflation port. Cords spaced equally around the circumference of the panel and fastened to the envelope wall will center the parachute and prevent it from exiting through the deflation port. Another set of cords from the edge of the panel is gathered together below the center of the panel and extends with a single line to the basket. Deflation is accomplished by pulling on the line, separating the parachute top from the edge of the deflation port, and allowing the hot air to escape from the envelope.

Venting on parachute top deflation system is accomplished by pulling on the deflation line for a short period of time. When the deflation line is then released, internal envelope pressures will cause the parachute top to close.

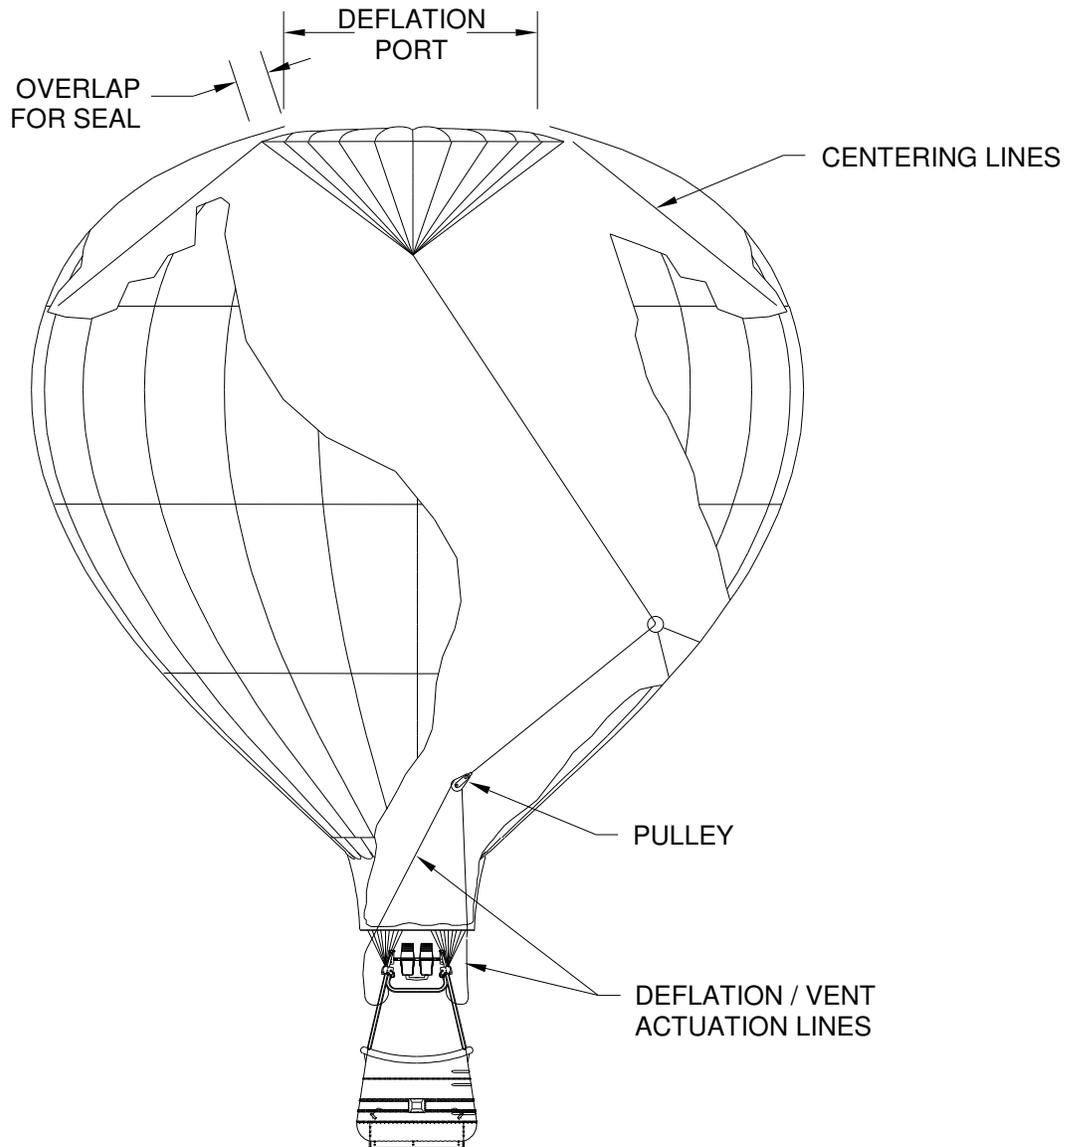
Figure 1.1.3 Pulley Parachute Envelope Design

The **PULLEY PARACHUTE** design, figure 1.1.3, employs a parachute style panel covering the deflation port. Cords spaced equally around the circumference of the panel and fastened to the envelope wall will center the parachute and prevent it from exiting through the deflation port. Another set of cords from the edge of the panel is gathered below the center of the panel and extends with a single line to a pulley. A deflation line runs through the pulley and attaches to the load block on the basket at corners 1 & 2. Deflation is accomplished by pulling on either side of the line, separating the parachute top from the edge of the deflation port allowing the hot air to escape from the envelope.

Venting on parachute top deflation system balloons is accomplished by pulling on the deflation line for a short period of time. When the deflation line is then released, internal envelope pressures will cause the parachute top to close.

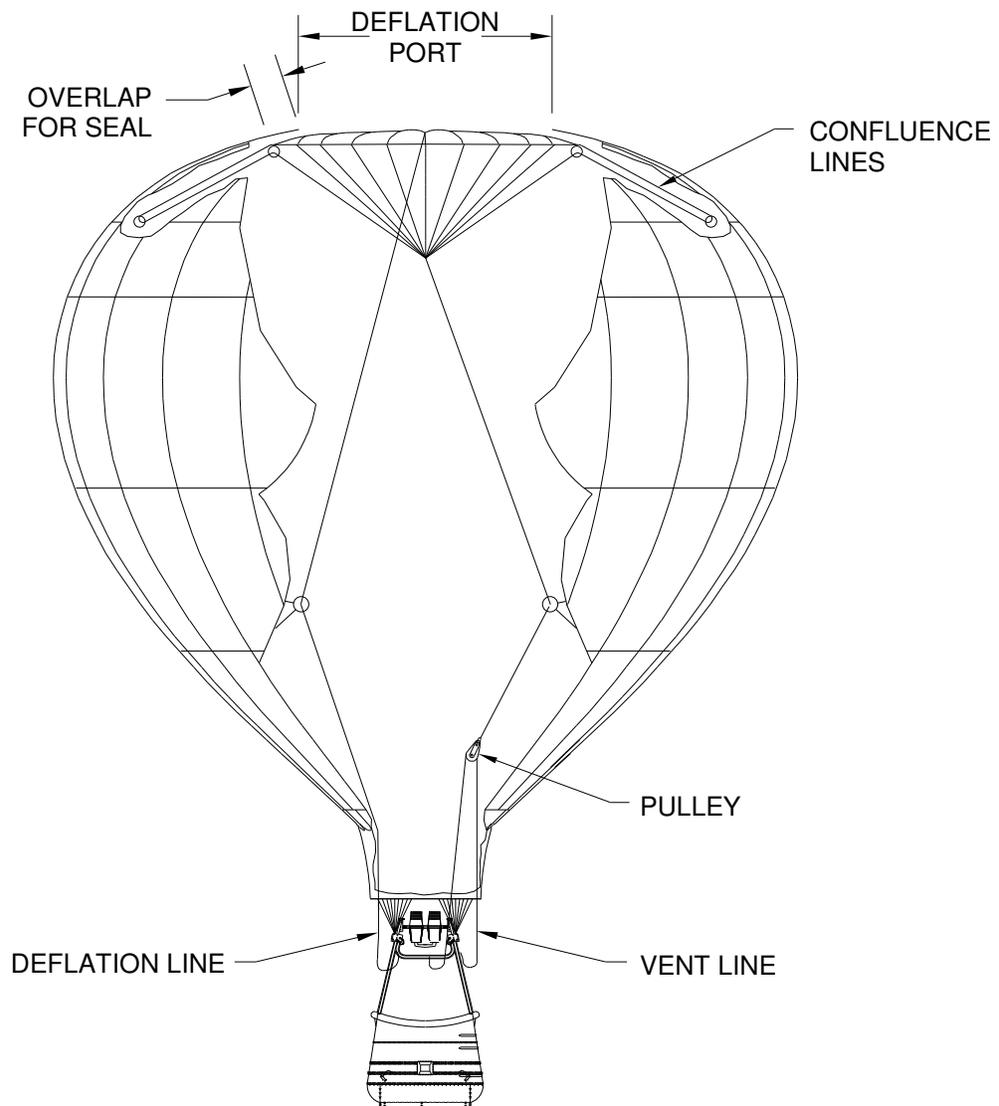
Figure 1.1.4 Aerochute Envelope Design

The **AEROCHUTE TOP CAP** design, figure 1.1.4, employs a parachute style panel covering the deflation port. Combination cords are tied to a ring at the confluence point, and are routed through a ring at the top cap edge, through a ring at the stickman anchors, and back to the cap edge where they are tied off. The vent line runs from the confluence ring down to the basket with a pulley advantage identical to the pulley parachute. Venting is accomplished by pulling on either side of the pulley line, separating the top cap from the edge of the deflation port allowing the hot air to escape from the envelope.

Deflation on Aerochute top cap deflation system is accomplished by pulling on a red strap routed to the center of the top cap. The combination cords serving as both centering cords and confluence lines allow the cap to be drawn inward and down affecting a rapid deflation. A quick pull on the vent line will reverse the deflation process and reseal the top cap.

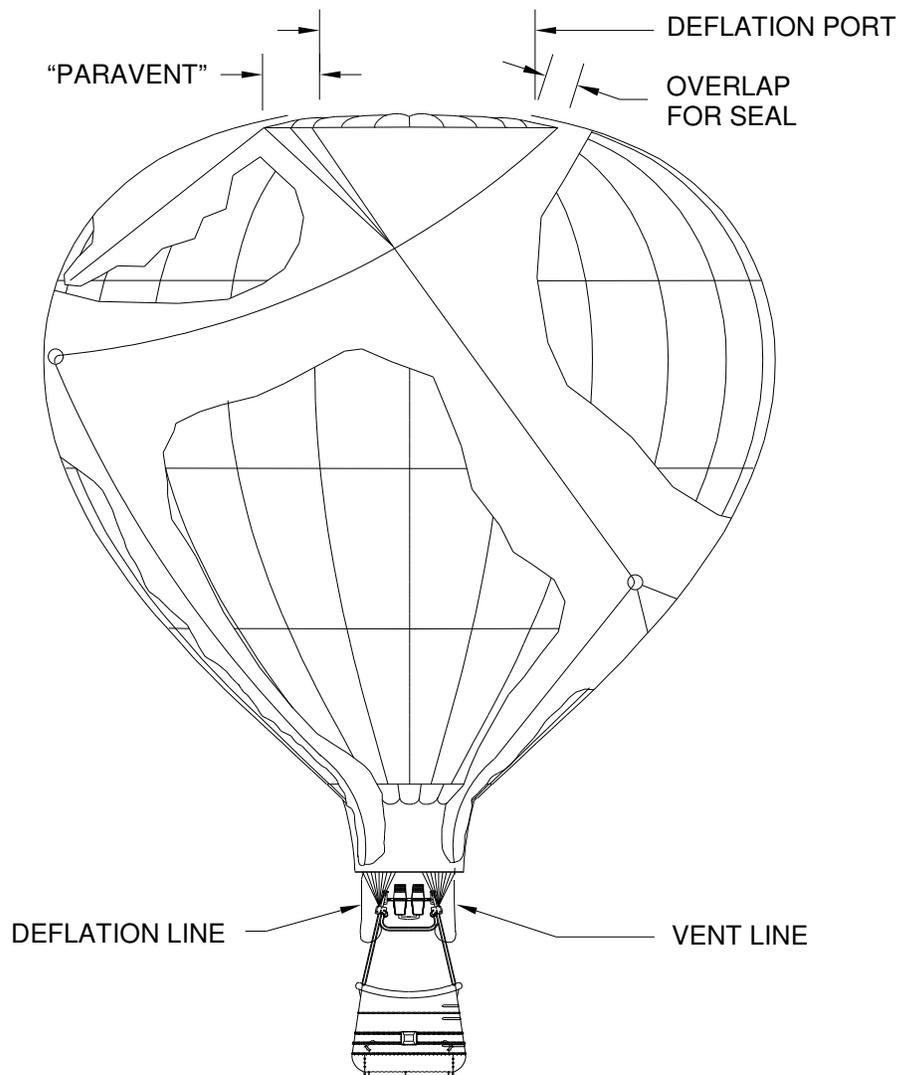
Figure 1.1.5 Spring Top™ Envelope Design

The **SPRING TOP™** design, figure 1.1.5, uses an oversized panel covering 1/3 of the deflation port. The Spring Top™ is very similar to the rip top in 16, 20 and 24 gore balloons in that the 2/3 portion overlaps the port opening by 12" and torsion springs and pockets (Figure 1.1.6) are used for retention of the deflation panel.

The paravent of the Spring Top™ deflation system is located in the opposite 1/3 portion of the port opening. It is configured identically to the parachute top, except that the actuation line is routed to the opposite side of the envelope. Here, the overlap of the panel is the same as the other 2/3 and venting is accomplished by pulling the actuation line. Its action is the same as the parachute top, although on a smaller scale. This allows the Spring Top™ vent system the responsive nature of the parachute top.

The vent actuation and deflation lines of the Spring Top™ are also much different that the rip top lines in that they are Kevlar reinforced for burn through protection. Should the outer nylon cover burn away, the Kevlar reinforcement will char, but retain most of its strength so that the deflation/venting may still be accomplished.

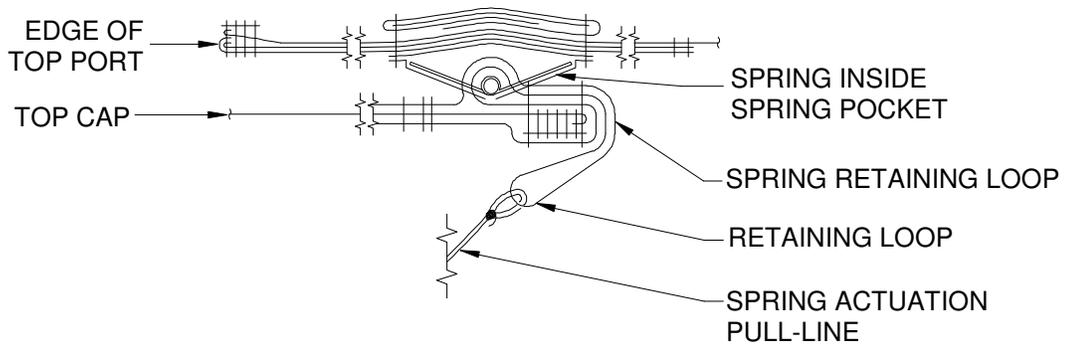
Figure 1.1.6 Spring/Pocket Interface

The spring and pocket combinations are located on untaped seams on S series balloons and both between seams and on seams on Rally balloons, centered 12" from the port edge. The torsion spring is attached to the deflation panel, and the retention pocket is attached to the envelope.

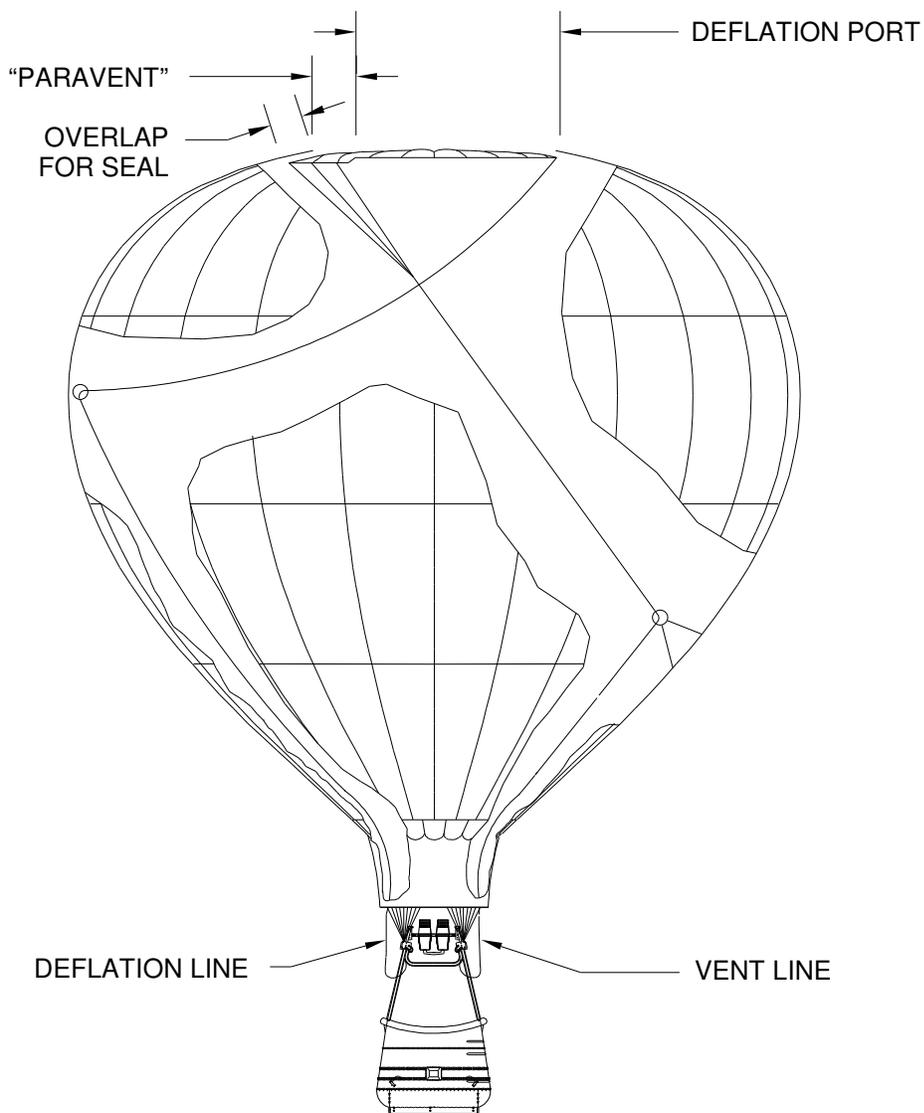
Figure 1.1.7 Para-Rip Top™ Envelope Design

The **PARA-RIP TOP™** design, figure 1.1.7, uses a circular panel with 2/3 sealed by the use of hook and pile fastener tape, identical to the rip top design. An actuation line is attached to the edge of the hook and pile fastener sealed “rip top” and extends to the basket permitting the panel to be pulled open as a means of deflating the envelope.

The para-vent of the Para-rip Top™ deflation system is located in the opposite 1/3 portion of the port opening. It is configured identically to the parachute top, except that the actuation line is routed to the opposite side of the envelope. Venting is accomplished by pulling the actuation line. The vent action is the same as the parachute top, although on a smaller scale, allowing the Para-vent system the responsive nature of the parachute top.

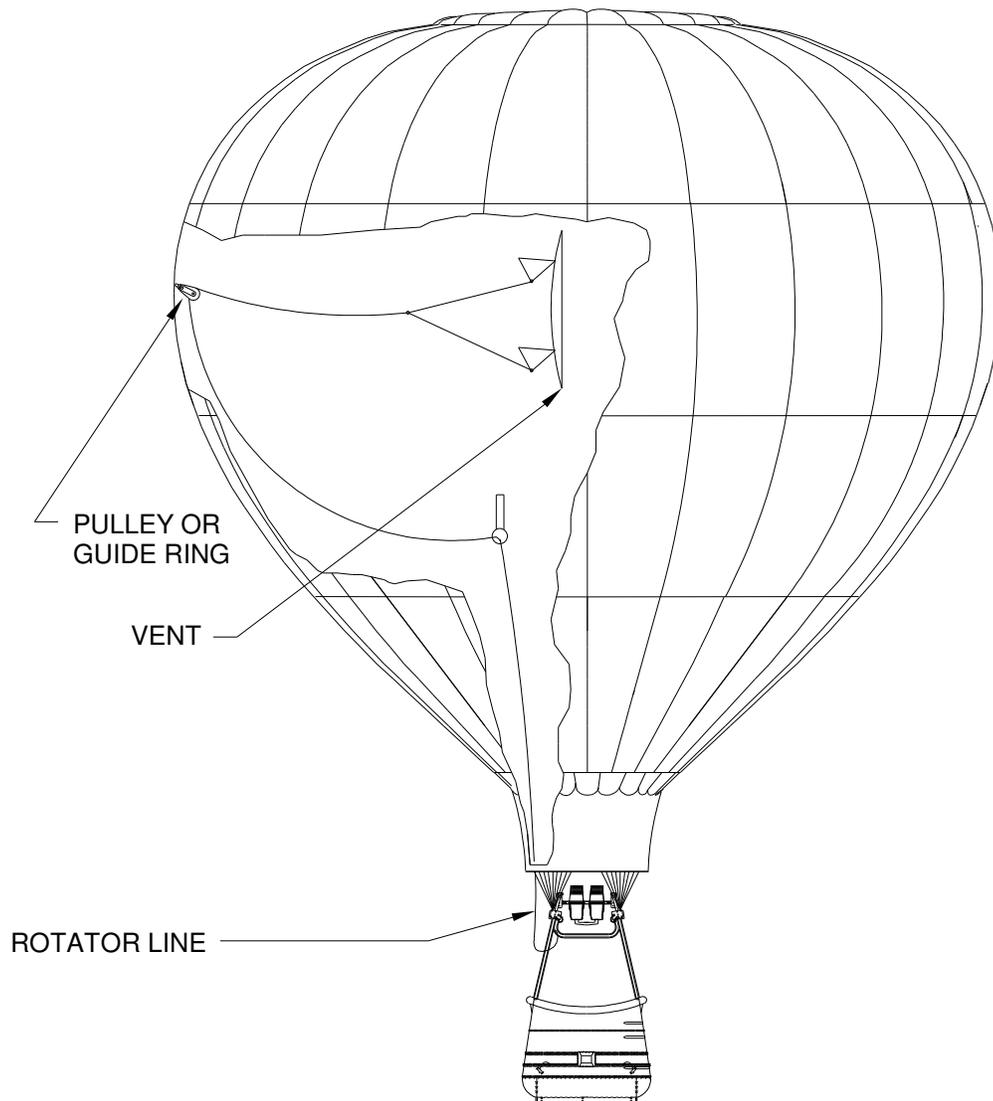
Figure 1.1.8 Rotator Vent – Single

Prior to January 1989, Spring Top* and Parachute Top systems had the option of being equipped with a rotator vent which is similar in design to the maneuvering vent, but is approximately $\frac{1}{2}$ the opening area and allowed rotation of the envelope in one direction. After that date, dual rotators were installed allowing rotation in either direction. This vent is not designed for normal venting off of excess amounts of hot air. Note: Rotator may use metal guide rings in place of pulleys, depending on year of manufacture.

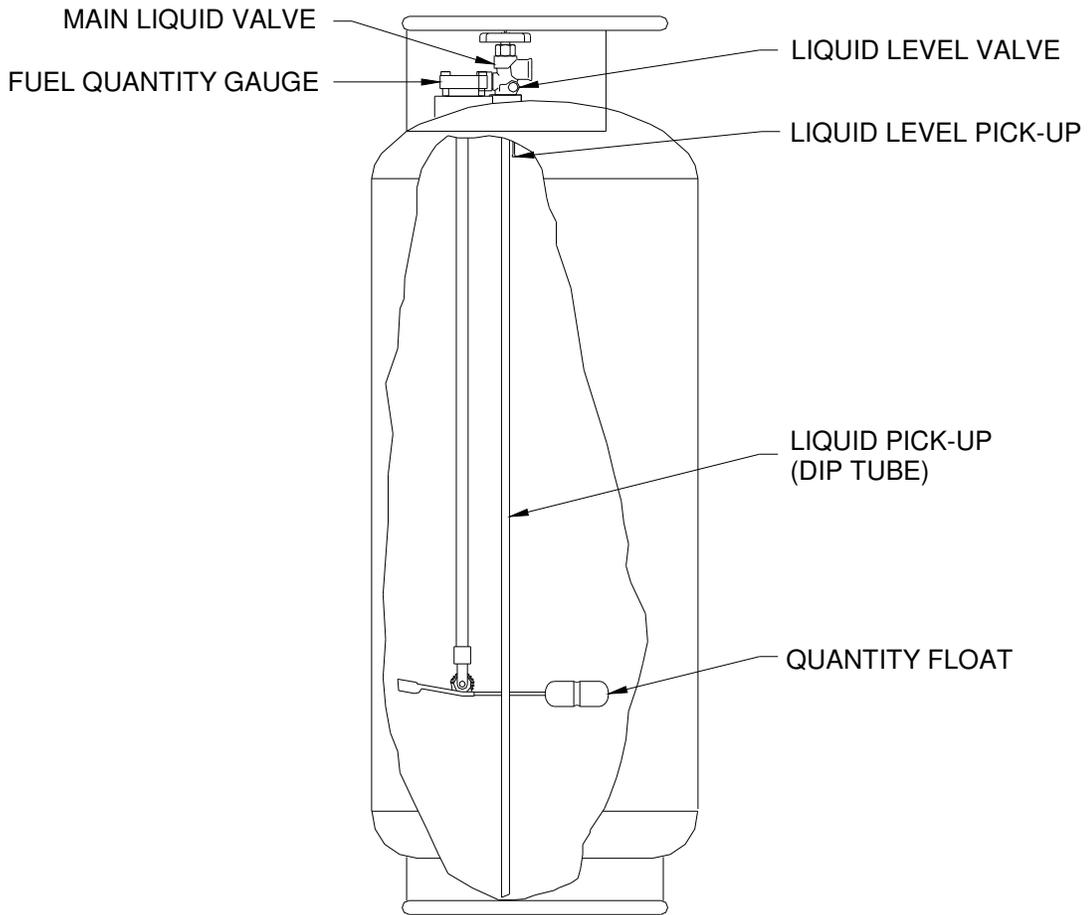
Figure 1.2.1 Vertical Fuel Tanks

<u>VERTICAL SINGLE SERVICE FUEL TANK</u>	
15 GAL. -	HEIGHT - 35.0" DIAMETER - 14.0"
18 GAL. -	HEIGHT - 40.25" DIAMETER - 14.0"
23 GAL. -	HEIGHT - 48.375" DIAMETER - 14.0"

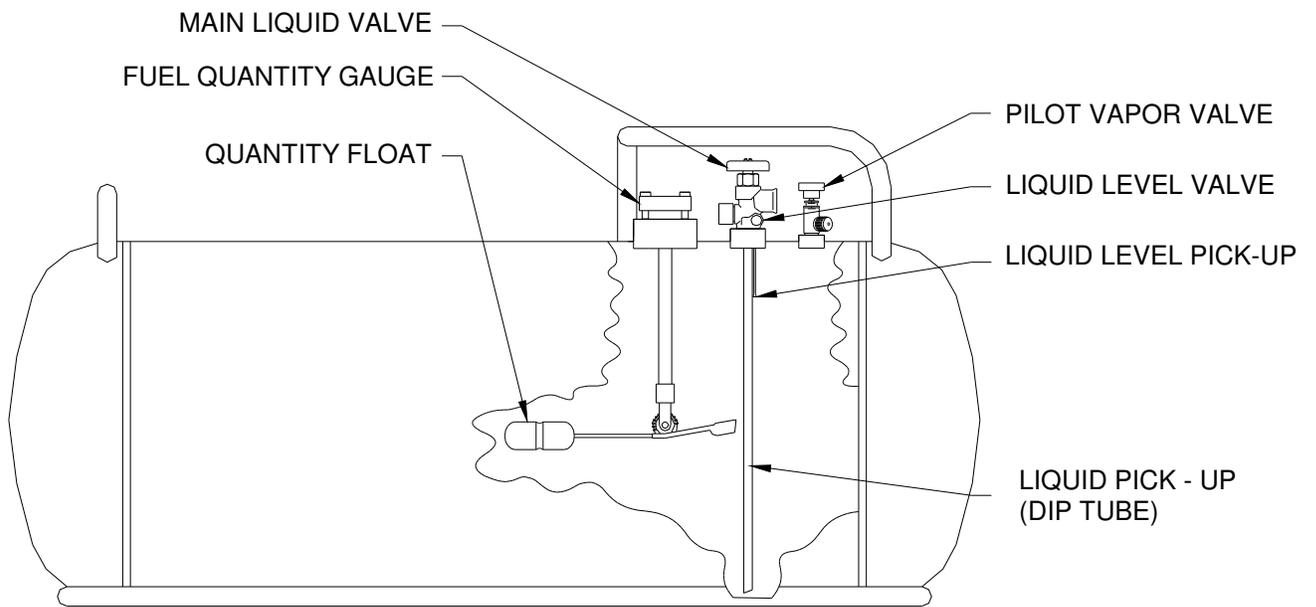
Figure 1.2.2 Horizontal Fuel Tank

<u>HORIZONTAL FUEL TANKS</u>	
H-20 -	LENGTH - 38.25" DIAMETER - 14.0"
H-25 -	LENGTH - 47.5" DIAMETER - 14.0"

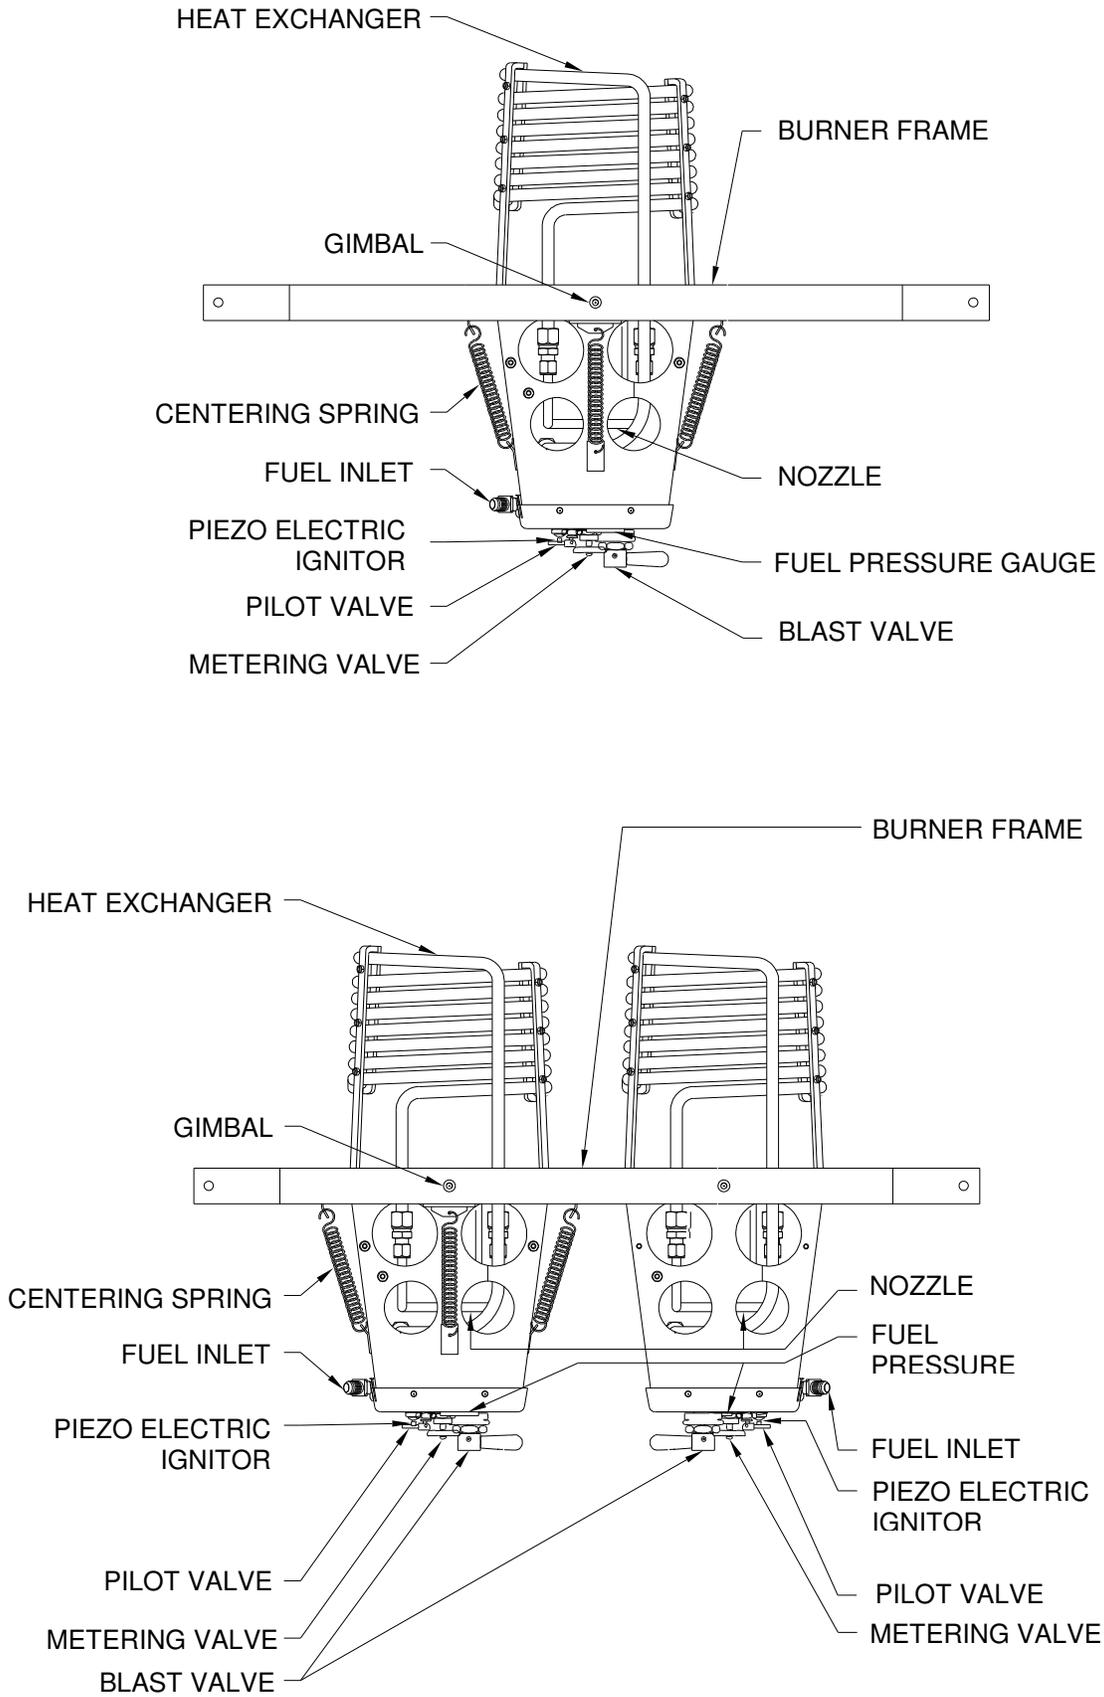
Figure 1.2.3 HPII Single and Dual Burner Systems
 Note: Depiction for update burners slightly different.

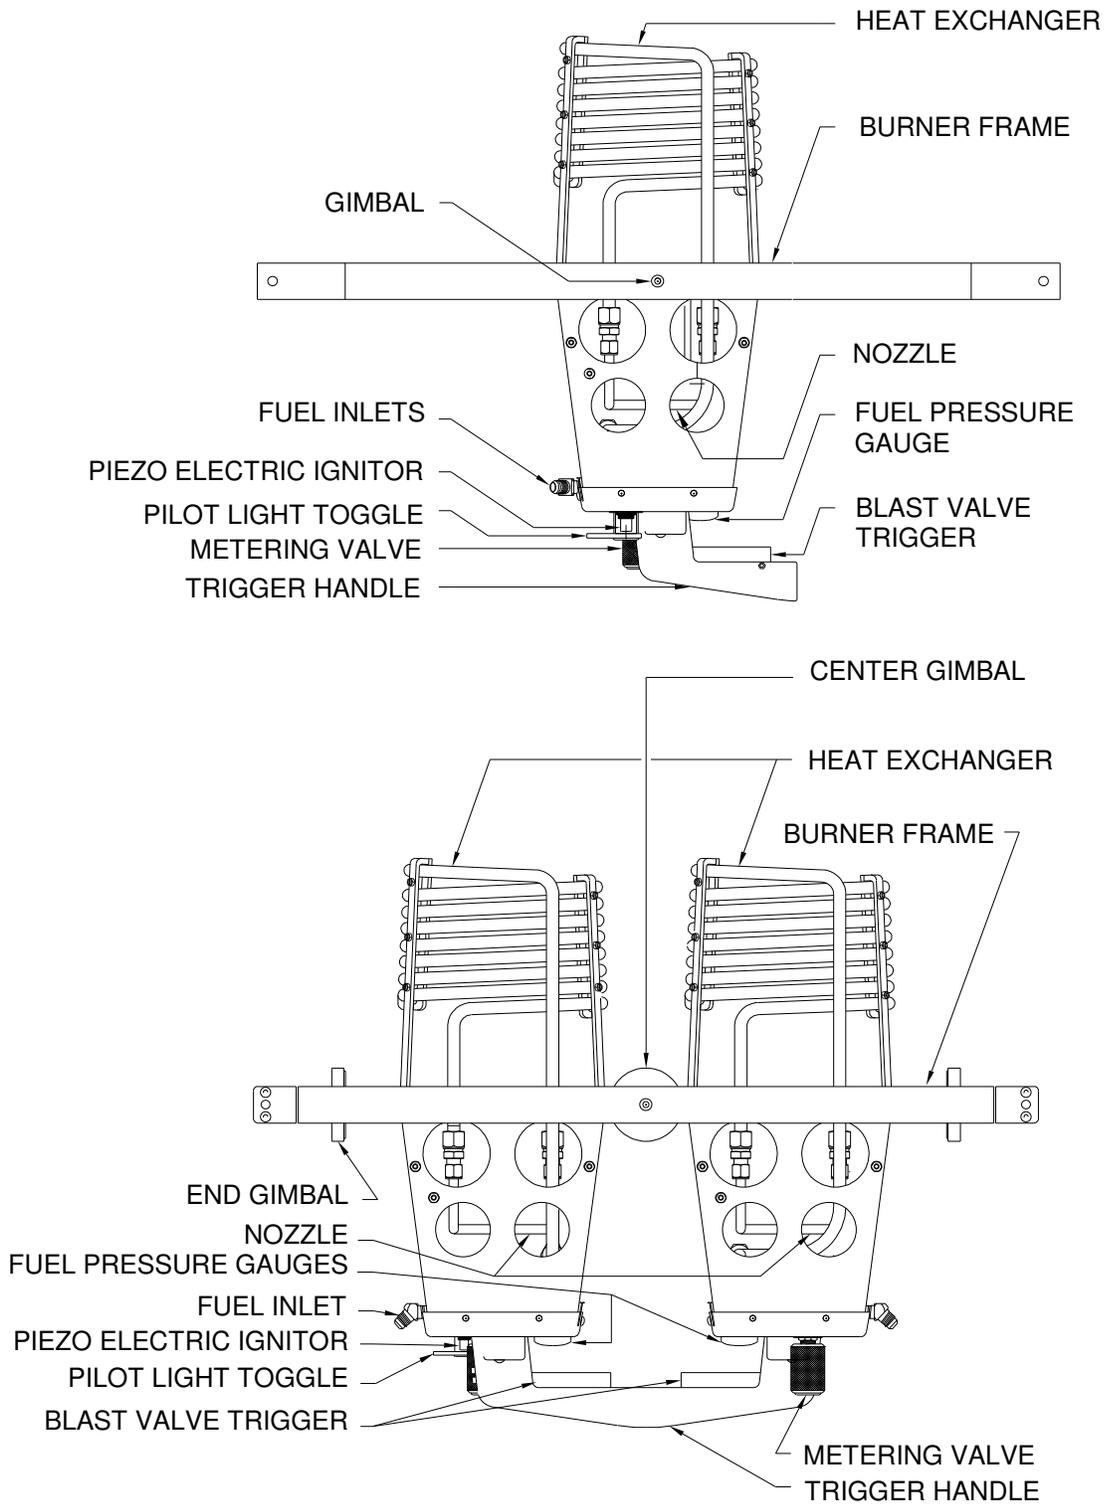
Figure 1.2.4 HPIII Single and Dual Burners
(optional glow valve not shown for clarity)

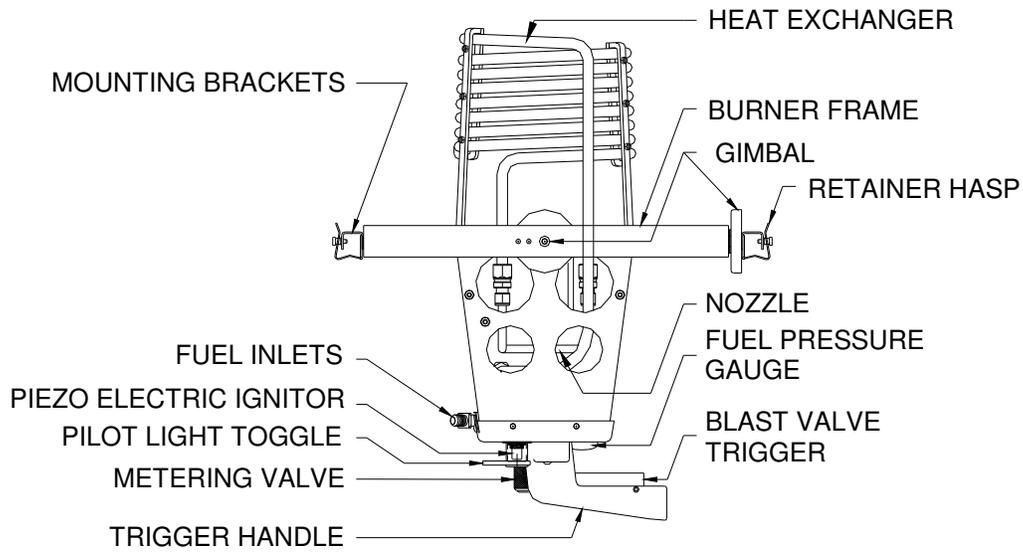
Figure 1.2.5 HPIII Single Burner Aurora (ELS)
(optional glow valve not shown for clarity)

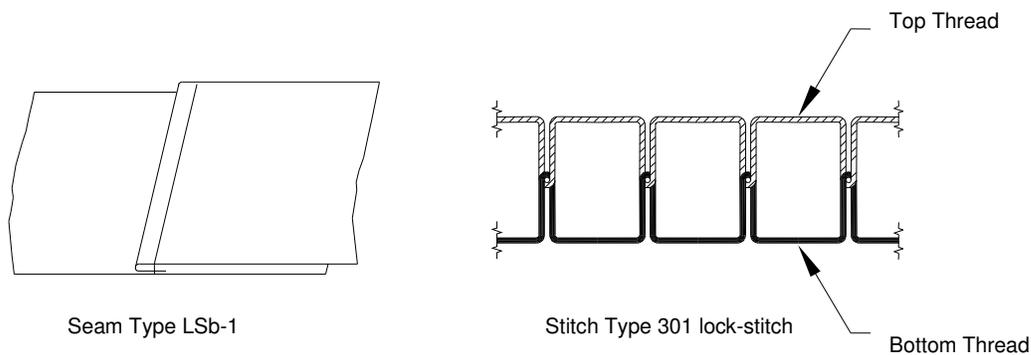
Figure 2.1 (9)
Skirt Repair Sewing Details

- Steps:
1. Cut a patch of material which is a minimum of 1½" beyond edges of tear or hole in each direction.
 2. Align weave of the patch with that of the area being repaired.
 3. Fold a hem and stitch over damaged area using type E polyester thread, a type 301 lock-stitch, seam type (LSb-1) using a single needle with a stitch size of 7-15 stitches per inch. An edge distance of 3/16" ± 1/16" MUST be maintained. See figure 2.1(9) for sewing details.
 4. The damage behind this type of repair may be trimmed out and an additional row of stitching sewn around the damaged area to better secure the repair. Maintain the edge distance of 3/16" ± 1/16".

- (4) Patching small holes in the envelope, within allowable damage limits, utilizing approved methods and materials. See section 2.1 item (1).
Patching holes or tears in the envelope skirt or dipper regardless of size, utilizing approved methods and materials. See Section 2.1 item (9).

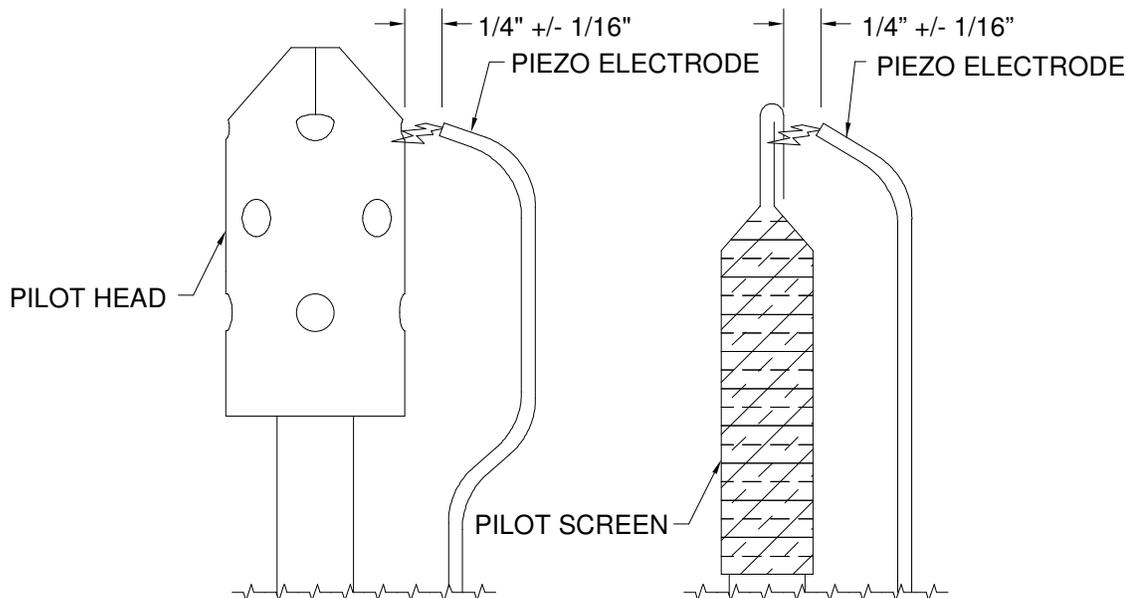
Figure 2.3 Adjustment of Piezo Electrode

- (7) Electric ignition or piezo - check that the electric sparker ignites the pilot light when activated, check the gap on the sparker electrode (see Figure 2.3). Inspect the power cables for no damage or loose connections, verify that the battery is charged (if applicable).

- (6) Replacing or cleaning spark plugs or electrodes on electric ignition system. Piezo-electric igniter cleaning and adjustment are considered applicable here (See Figure 2.3).
